# An Unusual Cause of Failure of a Total Knee Replacement

David F. Dalury, MD

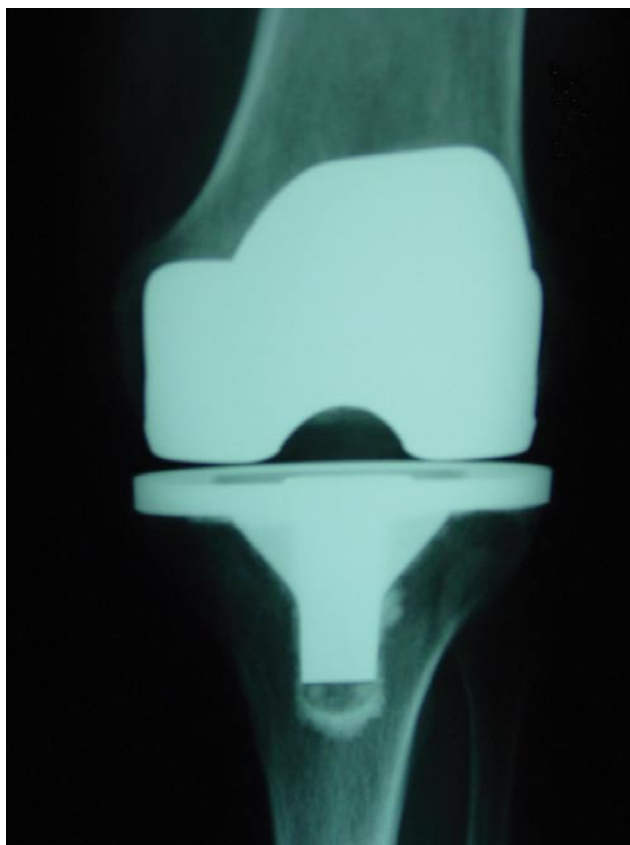
**Figure 2.** AP view of a well-aligned total knee replacement implant.

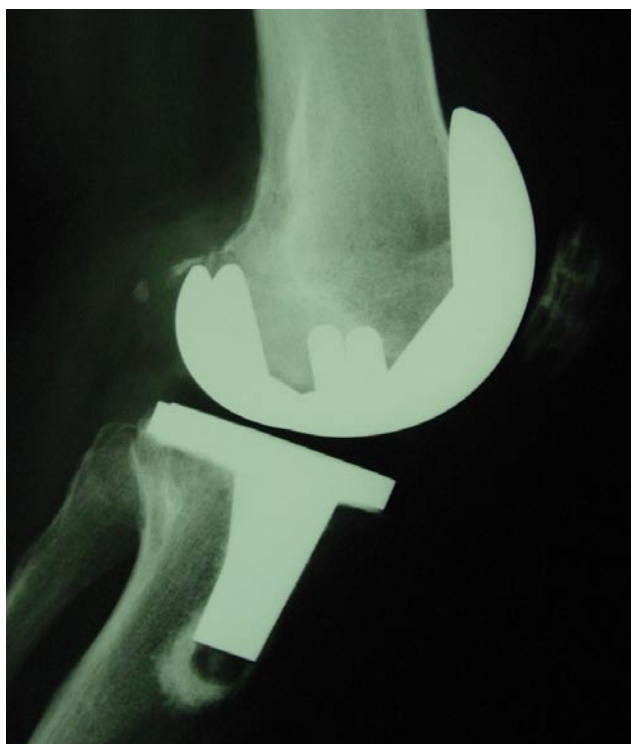
**Figure 3.** Lateral view of a well-aligned total knee replacement implant.

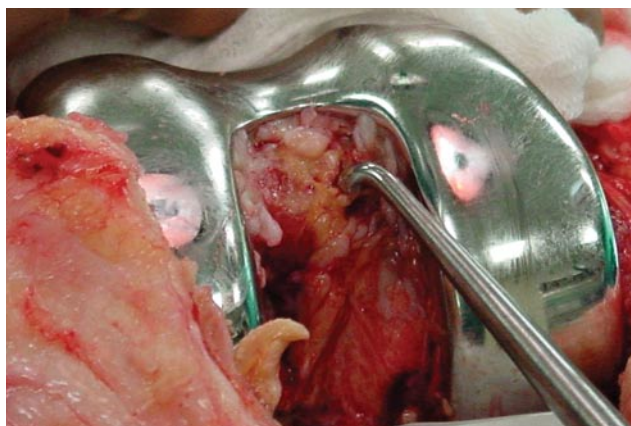
**Figure 4.** Patella polyethylene shows evidence of wear along the center—surprising for a 14-month-old implant.

ture, no crystals evident) and a reactive synovium. Femoral and tibial components were well fixed, and the tibial polyethylene showed basically no wear. The patella, which was well fixed and had a ring of soft tissue around the rim, showed evidence of polyethylene wear along the center of the polyethylene (Figure 4). With the capsule opened and the extensor mechanism in place, the knee was placed through an arc of motion, and crepitus was appreciated under the well-aligned and balanced patella. Inspection of the femoral notch revealed 2 large osteophytes, measuring at least 4 mm, that had formed where the bony plug had been placed and healed previously (Figure 5).

The osteophytes were removed, and the patella was revised without incident. At the 3-month, 1-year, and 6-
