# Allergic Reaction to Vanadium Causes a Diffuse Eczematous Eruption and Titanium Alloy Orthopedic Implant Failure

*Cutis.* 2017;99:245-249.

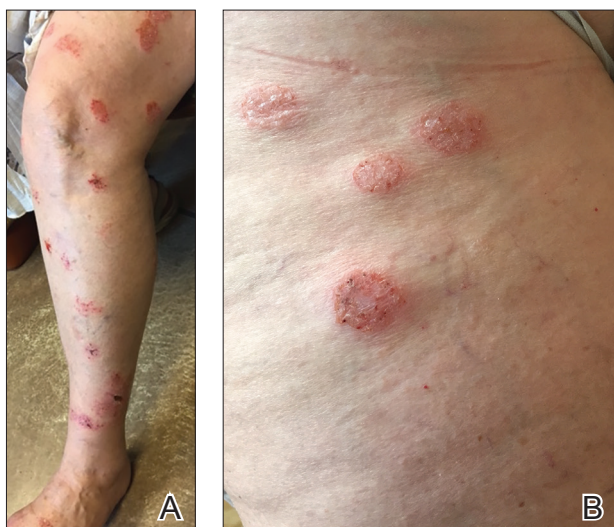
A 62-year-old woman who was otherwise healthy presented with an eruption of more than 80 pruritic, nummular, eczematous plaques on the arms, legs, back, and buttocks of 3 weeks' duration (Figure 1). She had a history of allergy to metal used in costume jewelry. Six weeks prior, the patient underwent implantation of a titanium alloy plate in the left foot for surgical repair of painful deforming osteoarthritis. A radiograph of the foot showed appropriate placement. According to the manufacturer, the plate was composed of the compound Ti6Al4V, which contained 90% titanium, 6% aluminum, and 4% vanadium. The lesions developed on the skin close to but not directly over the surgical site.

**Figure 1.** Vanadium allergy with eczematous plaques on the left leg (A) and right thigh (B).

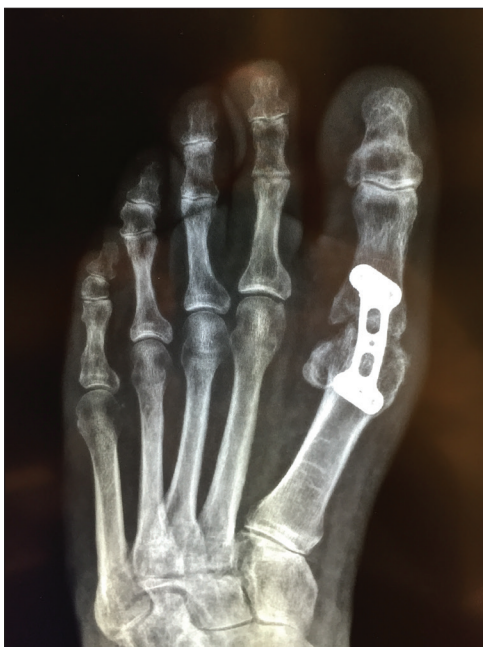
The patient had persistent pain and swelling at the surgical site, and radiographs taken post-operatively at 6 months showed implant failure (Figure 3). The hardware was surgically removed 8 months after implantation (Figure 4) and the plate and screws were submitted to the Institute for Mineral Resources Geosciences LA-ICP-MS Facility and the Lunar and Planetary Laboratory at the University of Arizona (Tucson, Arizona) for analysis. The skin lesions began to improve days after the hardware was removed and the eruption cleared over the following 3 weeks with no additional treatment.

**Figure 3.** Radiograph of the left foot prior to removal of the implant showed implant failure due to vanadium allergy.

Several weeks after implantation of a titanium alloy metal plate in the left foot, a widespread eczematous eruption developed in our patient who had no prior skin disease. The eruption was steroid responsive but did not clear until the plate was removed. Detailed metallurgy analysis confirmed that vanadium was present and was not homogeneously distributed in the plate. The plate also was different in composition from the screws. Additional studies showed that galvanic corrosion between the plate and the chemically different screws might have contributed to the release of vanadium in the tissue.

We suggest that manufacturers consider vanadium-free alloys such as Ti7Al6Nb, which contains niobium instead of vanadium, in their surgical implants,<sup>22</sup> and if surgeons have a choice, they should consider using titanium implants with niobium rather than vanadium.<sup>10</sup> We suggest that clinicians consider vanadium allergy in patients with Ti6Al4V surgical implants and signs of a hypersensitivity reaction, and include vanadium trichloride 1% when patch testing.

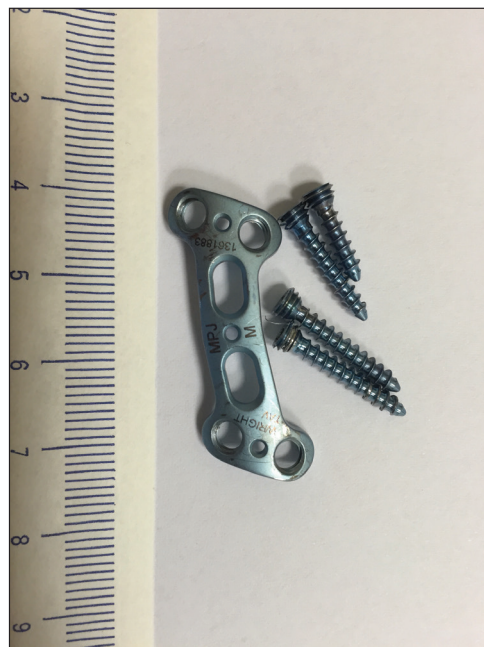
The plate and screws removed from the patient were sterilized and submitted for analysis. Electron microprobe analysis confirmed that the major elemental composition of the plate and screws essentially matched the manufacturer's listing (Table 1). The trace elements were determined using laser ablative inductively coupled mass spectroscopy, which demonstrated that the screws were of different metal composition from the plate (Table 2). Electron microprobe analysis also was used to determine the microstructure of the plate and screws. The plate had 2 distinct phases consisting of a titanium-aluminum phase and a vanadium phase, whereas the screw was much more homogeneous. Basic electrochemical studies were performed in a salt solution replicating the tissue of the foot. These studies showed that galvanic corrosion could have occurred between the plate and screws due to the differences of composition.

**Figure 4.** Surgical hardware containing vanadium after removal from a patient who demonstrated an allergic reaction.
