Metallosis After Metal-on-Polyethylene Total Hip Arthroplasty

Cara A. Cipriano, BA, Paul S. Issack, MD, PhD, Burak Beksaç, MD, Alejandro González Della Valle, MD, Thomas P. Sculco, MD, and Eduardo A. Salvati, MD

Am J Orthop. 2008;37(2):E18-E25. Copyright Quadrant HealthCom Inc. 2008. All rights reserved.

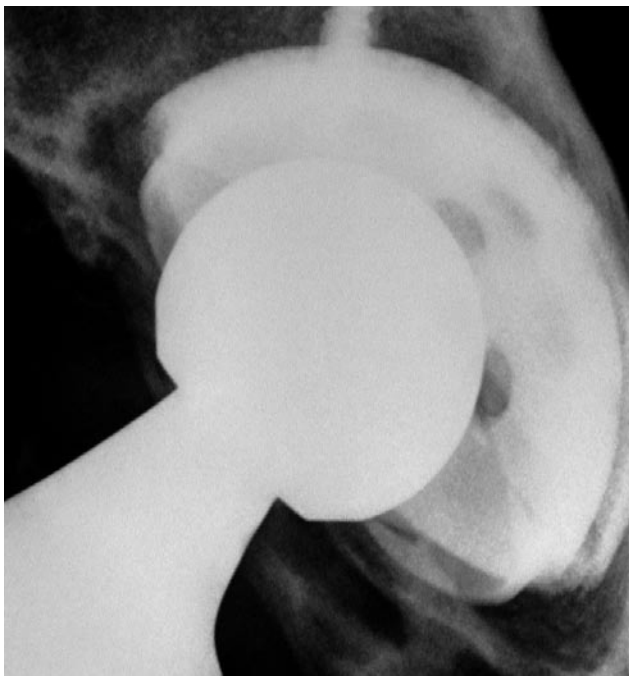
Figure 2. Fiber metal mesh shedding of a Harris-Galante type 2 acetabular cup (Zimmer, Warsaw, Ind) with periprosthetic osteolysis.

Recently, Mayman and colleagues⁶² reported on 5 patients who presented with fiber metal mesh shedding of a Harris-Galante type 2 acetabular cup 11 to 15 years after implantation. All 5 presented with hip pain, and 4 demonstrated gross acetabular loosening and fiber metal separation on preoperative x-rays. Loosening and fiber metal separation were confirmed during surgery. Progressive osteolysis was evident in the iliac bone in 4 cases. Osteolytic bone loss can lead to loss of adequate fixation, and, as the component moves, the remaining ingrown fibermesh detaches from the loose component⁶² (Figure 2).

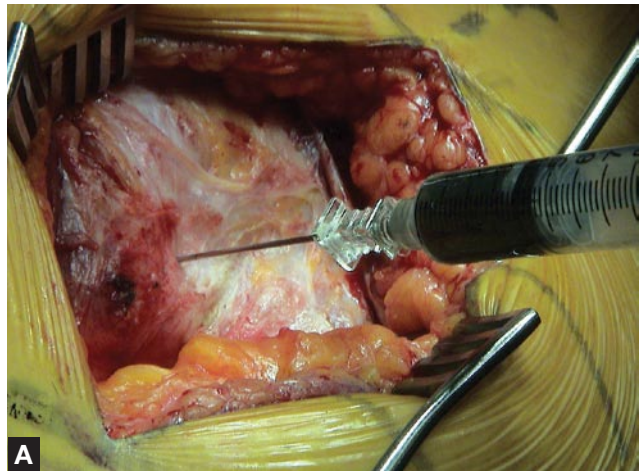
Figure 6. Metallosis in vivo. Intraoperative photographs at revision hip surgery show (A) black fluid aspirated from hip joint; (B) black fluid filling joint space, metallic staining of periprosthetic tissues, and polyethylene liner dislodgement; and (C) extensive metallic debris, polyethylene liner, and acetabular shell damage.

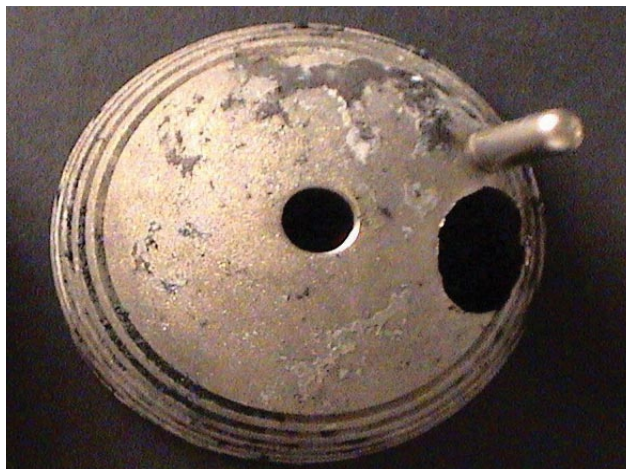
Figure 8. Worn-through shell. Retrieved acetabular component after revision for metallosis shows complete wear-through.

ed from articulation with the harder cobalt-chrome femoral head, eventually resulting in shell penetration (Figure 8). Backside wear may manifest as scratching and absence of machine lines on the convex surface of the insert.¹³ Femoral component subsidence may also be observed, with polishing at all 4 facets, especially the posteromedial and
