Mechanical Failure of Marathon Cross-Linked Polyethylene Acetabular Liner After Total Hip Arthroplasty

Matthew O. Barrett, MD, Douglas W. Van Citters, PhD, and William G. Hamilton, MD

CASE REPORT

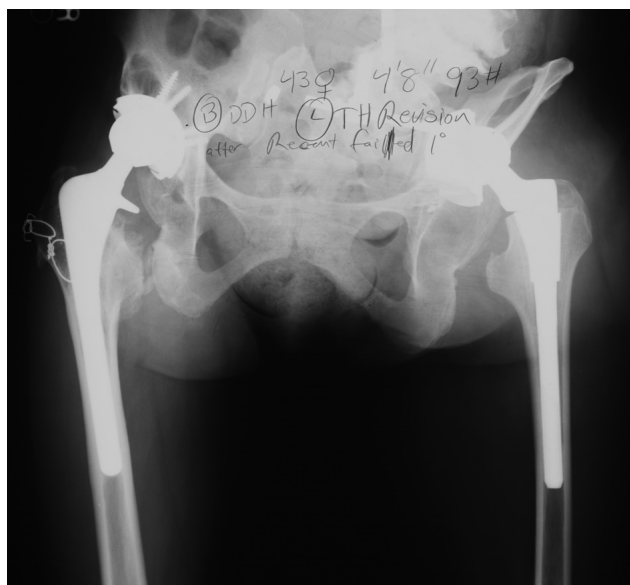
Figure 1. Anteroposterior pelvis radiograph shows displaced left acetabular component and contralateral osteolysis and wear.

A 46-year-old woman (weight, 95 lb; body mass index, 19.6 kg/m²) underwent left primary THA at an outside facility 2 years earlier. The original diagnosis was degenerative disease secondary to hip dysplasia. Severe scoliosis and a significant fixed pelvic obliquity were noted. An S-ROM (DePuy) femoral component was used. The patient presented to our clinic 2 weeks after the THA with severe pain in the left groin and was found to have a grossly displaced acetabular shell. Her contralateral right THA was clinically functioning well 18 years after surgery, despite significant osteolysis and wear (Figure 1). She expeditiously underwent revision of the loosened acetabular component without complication. A Pinnacle Bantam (DePuy) acetabular shell with an outer diameter of 46 mm was placed and augmented with a dome screw (Figure 2). A Marathon (DePuy) cross-linked liner with an inner diameter of 28 mm and an offset of +4 mm was placed. A 10° face changing liner with posterosuperior oriented elevation was used to enhance stability. Postoperative radiographs showed cup abduction angle of 64°. Two years and 10 months after THA, she presented acutely to our clinic with painful popping in the operative hip. Clinical examination revealed palpable clicking and popping in the hip with passive range of motion.

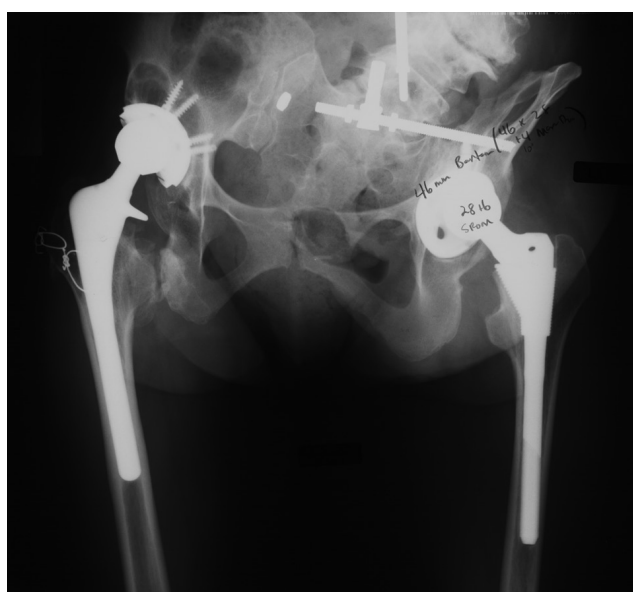
Radiographs showed acute superior migration of the left femoral head into the well-fixed acetabular shell (Figure 3). Revision of the liner was undertaken. The polyethylene was found to be fractured at the anterosuperior margin (Figure 4), and the shell was stable and was left intact. Polyethylene thickness was increased, particularly in the areas of highest stress, by downsizing the ball to 26 mm and superiorly orienting a 10° face changing liner with offset of +4 mm (Figure 5). The patient sustained an early postoperative dislocation, but at 1-year follow-up was doing well.

Figure 3. Anteroposterior pelvis radiograph. Left femoral head has migrated into apparently well-fixed acetabular shell.

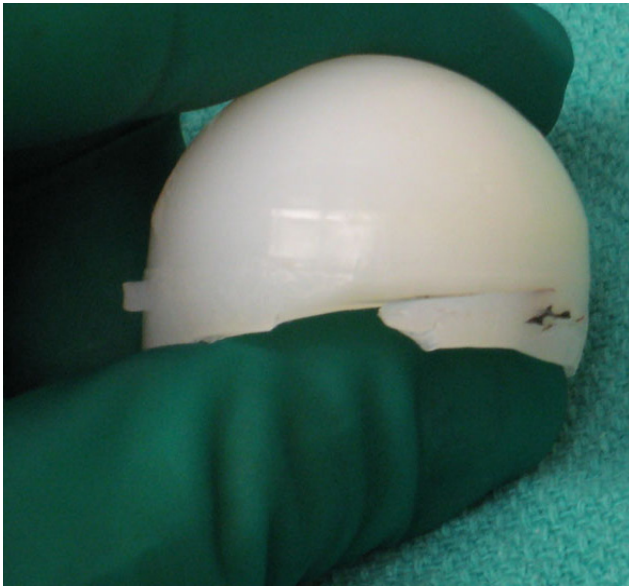
The cup was fractured in the anterosuperior quadrant. Fracture analysis showed that the failure was fatigue related and that the crack had begun at the outer diameter and propagated inward. The locus of crack initiation was the site of one of the missing alignment pegs.

It was hypothesized that the initial event leading to failure of the THA was mechanical failure of the anterior alignment peg and the locking mechanism. This failure allowed the liner to rotate, imposing high stresses on the remaining alignment pegs. As the device rotated in its shell, the nonspherical rim of the device was articulated against the spherical interior of the shell. The lack of geometrical conformity, coupled with the loads imposed by the patient on the superior rim during gait, led to substantial tensile stresses in the region of the sheared-off alignment peg. These stresses were sufficient to cause crack propagation.

Figure 4. Intraoperative photograph of failed highly cross-linked acetabular liner. Fracture is at anterosuperior rim.

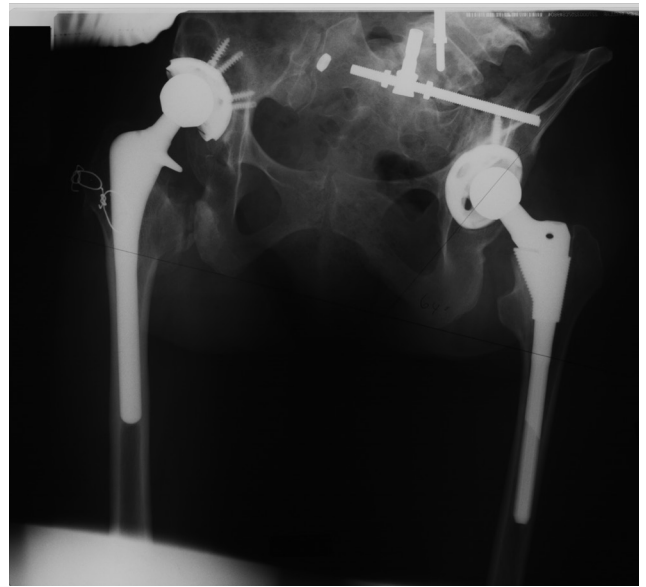
Figure 5. Anteroposterior pelvis radiograph after revision of fractured acetabular liner and downsizing of femoral head.

Surgeons should be aware of the minimum polyethylene thickness, particularly the thickness at the rim. Manufacturers often report thickness at the dome, not at the rim. We cannot recommend a minimum threshold but exercise caution when the polyethylene is less than 6 mm thick. In such cases, downsizing the femoral head in favor of thicker polyethylene may be prudent. We chose this option when revising our patient's fractured liner. Unfortunately, doing so decreased hip stability, and the patient sustained a postoperative dislocation. In hind-
