Use of an Absorbable Plate in the Management of a Clavicle Fracture in an Adolescent

Eric W. Edmonds, MD

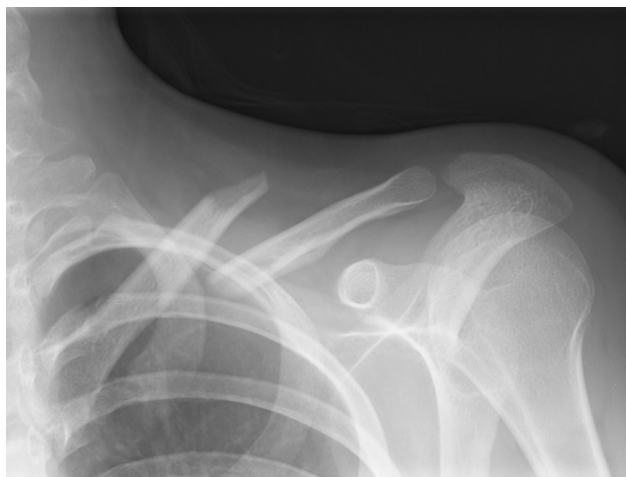
Figure 1. At initial presentation, anteroposterior radiograph of left shoulder shows displaced and shortened clavicle fracture.

A right-handed, 17-year-old girl injured her left shoulder and right wrist in a fall from a mountain bike. Initial management at an outside emergency department consisted of a simple sling for a left midshaft clavicle fracture (Figure 1) and a volar wrist splint for a right comminuted intra-articular distal radius fracture. One day later, the patient received a univalved short arm cast with appropriate molding and underwent computed tomography for the intra-articular fracture. No tenting of the skin over the clavicle was noted during this visit to our facility.

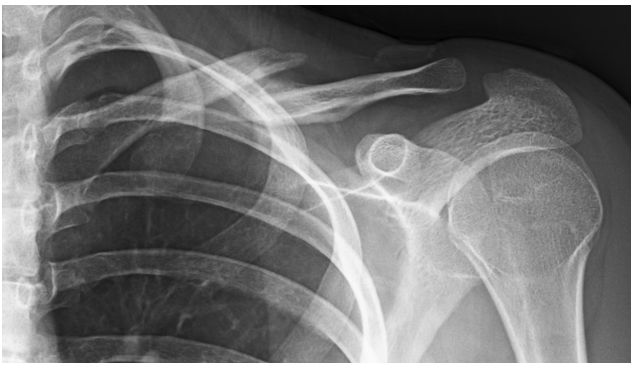
Figure 2. Three months after injury, anteroposterior radiograph of left shoulder shows some callus formation but continued radiographic lucency.

obvious deformity and prominence. ROM was nearly symmetric, lacking only 5° in forward elevation and external rotation, as compared with the contralateral shoulder. At this time, the wrist was doing well, and the only deficit was 5° less extension in comparison. The patient reported that, as wrist symptoms decreased, she was becoming more aware of increasing pain in the clavicle. An anteroposterior radiograph of the clavicle showed some callus formation but continued lucency at the fracture site (Figure 2).

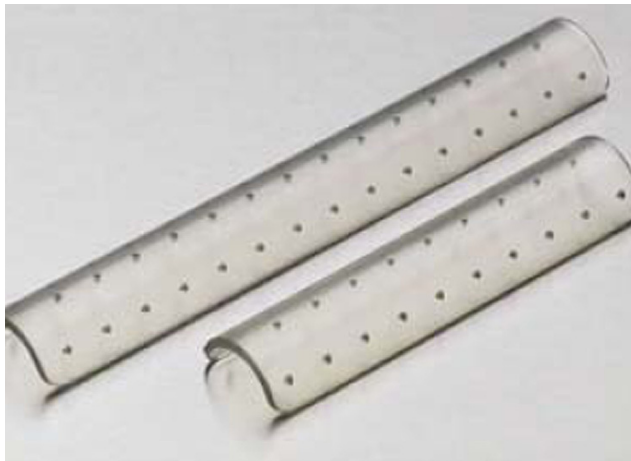
Figure 3. Concave FreedomPlate (Inion, Weston, Florida).

The patient elected to undergo ORIF of the clavicle secondary to painful delayed union (this procedure was performed 14 weeks after injury). She requested an implant that would not have to be removed, and was therefore fixated with the biodegradable OTPS FreedomPlate (Inion, Weston, Florida) (Figure 3) and six 2.8-mm compatible screws. The surgery involved a standard anterior approach. The fracture was found to have abundant callus but no union. Excess bone was removed and saved for use as bone graft. The fracture was reduced and held in transient fixation with a 0.062-in Kirschner wire. The 100-mm concave implant was chosen and cut to a length of 75 mm to match the need of the patient. The implant was placed in a warm saline bath, per manufacturer instructions, and then was

It is important to understand the fixation system used. The OTPS FreedomPlate is made of 3 polymers: trimethylene carbonate, L-lactide, and D,L-lactide. The materials are amorphous and degrade by hydrolysis, gradually losing their strength 4 months to 9 months after implantation. They are metabolized into carbon dioxide and water, achieving complete resorption within 2 years to 4 years. The stiff plate, after being heated

in the warm saline bath, becomes malleable, which allows for bone-specific contouring. This process can be repeated without fatiguing the plate. The biodegradable screws can be placed anywhere on the plate, as there are no preplaced holes, and the implant allows for off-axial placement. If the drill holes are tapped, then the screws will interlock with the plate. Once interlocked, the screw heads can be cut off flush with the plate to minimize the profile of the construct.

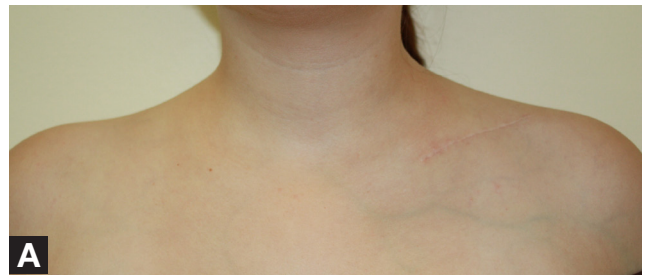
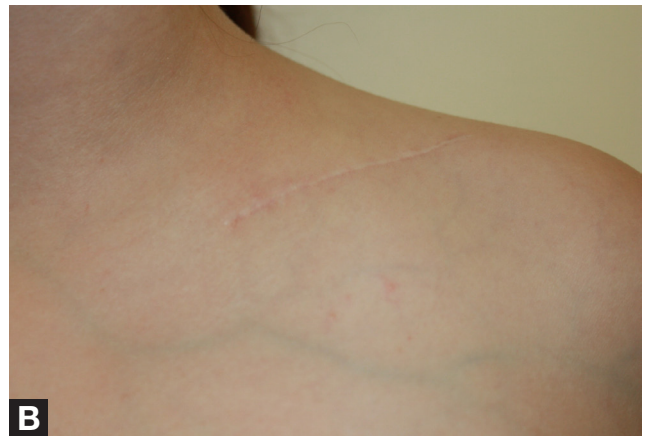
Figure 4. Clinical photographs. (A) Bilateral shoulders symmetrical in contour. (B) Left shoulder with well-healed incision and no evidence of cutaneous irritation.

with the left shoulder but some limitation with the right wrist. Physical examination revealed full active shoulder ROM and a well-healed incision with no evidence of erythema or underlying reaction to the implant (Figure 4). The area over the former fracture site was nontender to palpation. The plate edges were not discernible, but remnant plate was palpable under the skin. In addition, the right wrist was nontender, and the incision was well healed. The patient's overall DASH (Disabilities of the Arm, Shoulder, and Hand) Outcomes Measure score was 9.5, and her optional Work module score was 0 (she indicated she worked in "food service, housekeeping, basic construction remodeling"). Explaining she did not do sports or play musical instruments, she did not complete the optional Sport module. Final radiographs showed a well-healed fracture with continued radiographic evidence of the biodegradable screws (Figure 5).
