What's Wrong With This Picture?

A 90-year-old woman, admitted for altered mental status, just had a nasogastric tube placed to facilitate nutrition and medication delivery. The ICU nurse asks you to review an abdominal radiograph to confirm correct placement, since several attempts by various hospital personnel were required before they felt they had the tube in place.

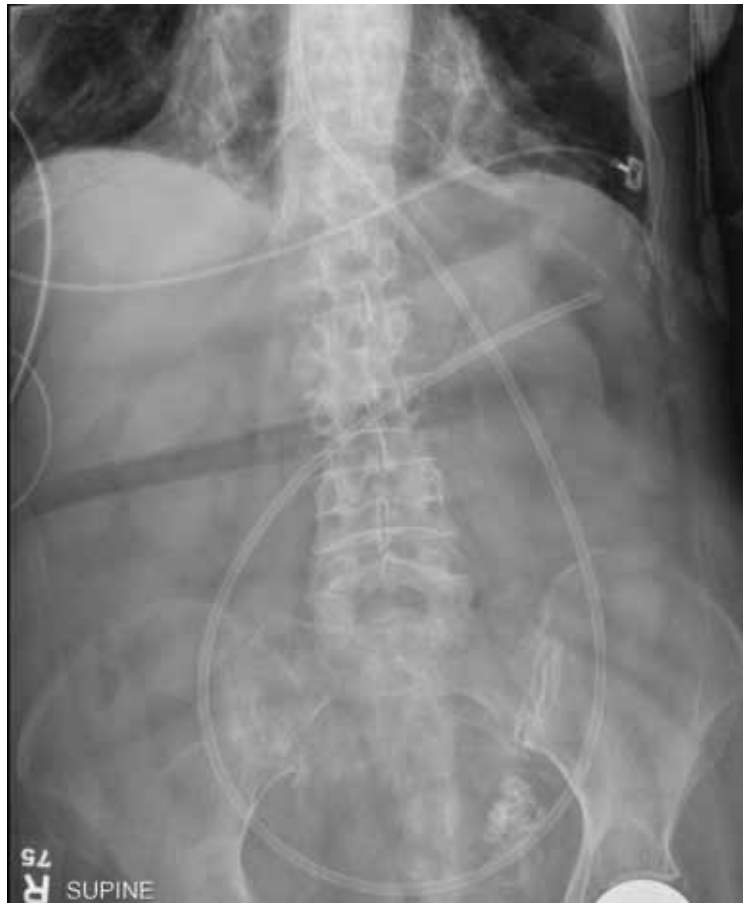
Portable KUB radiograph is shown. What is your impression?

The radiograph shows an enteric tube passing through the gastrointestinal tract. However, it extends low into the left lower quadrant, loops around the right lower quadrant, and then heads up toward the left upper quadrant. Such a course is atypical and concerning for displaced position.

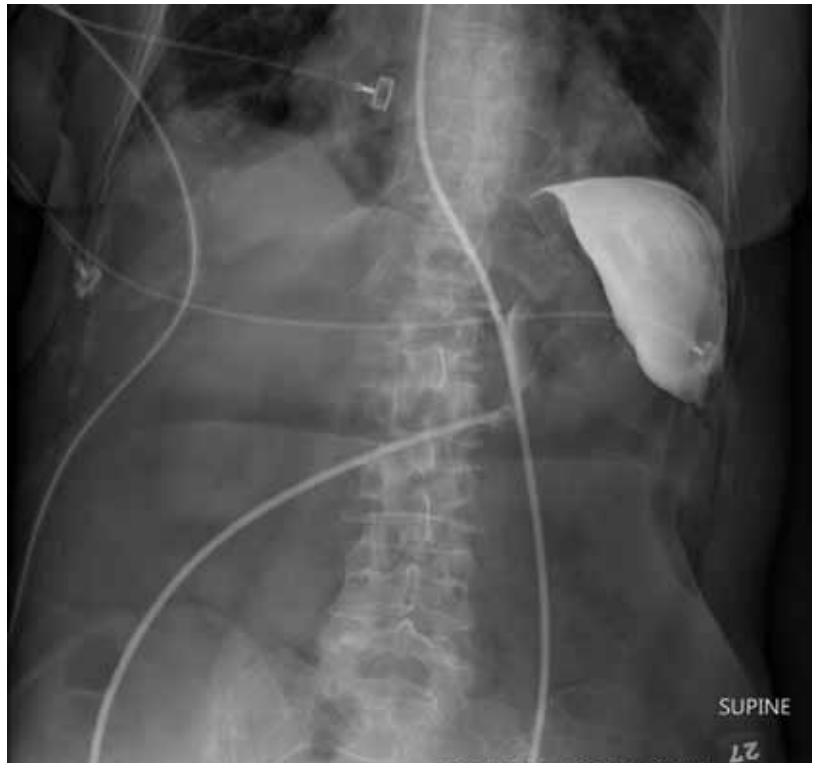
The radiologists concurred, and it was decided to instill some water-soluble contrast and repeat the KUB for further evaluation. That image is shown here. Note that the contrast does not appear to be in the stomach, as no gastric folds are visible. It accumulates in the left upper quadrant, under the diaphragm. Such a finding is concerning for possible gastric perforation.

The tube was promptly withdrawn, and urgent surgical consultation was obtained. **CR**
