# Tibial Fracture After Total Knee Arthroplasty Treated With Retrograde Intramedullary Fixation

Kevin M. Doulens, MD; Atul B. Joshi, MD, MCh(Orth), FRCS; and Russell A. Wagner, MD

Am J Orthop. 2007;36(7):E111-E113. Copyright 2007. Quadrant HealthCom Inc.

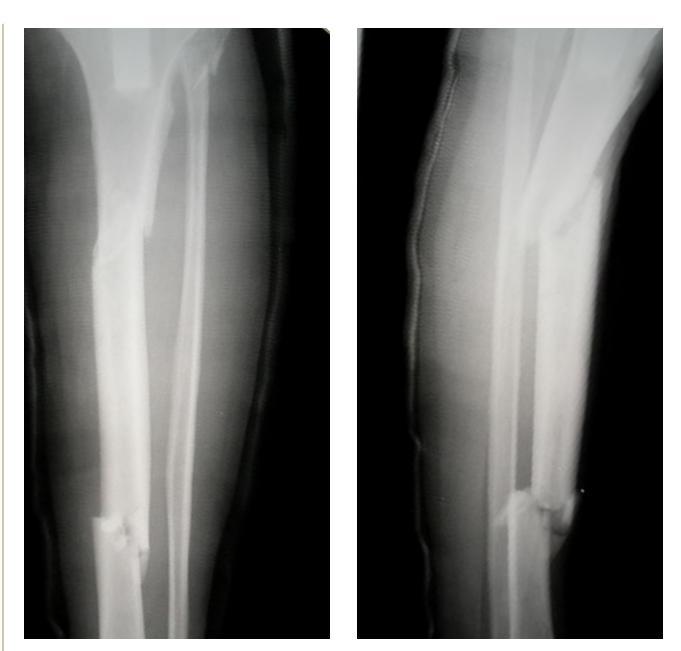
Figure 1. Initial anteroposterior plain film of the tibia.

Figure 2. Initial lateral plain film of the tibia.

A man in his early 60's was the unrestrained driver of a car that struck a large stationary object at high speed. The patient sustained multiple injuries, including a traumatic brain injury, bilateral pneumothoraces, a left scapular fracture, a left transverse and posterior wall acetabular fracture with hip dislocation, left superior and inferior pubic rami fractures, a displaced pubic symphysis, and a left segmental tibia fracture (Figures 1 and 2). The patient's surgical history was significant for previous right-sided total hip and left-sided total knee arthroplasties performed secondary to severe osteoarthritis years previously.

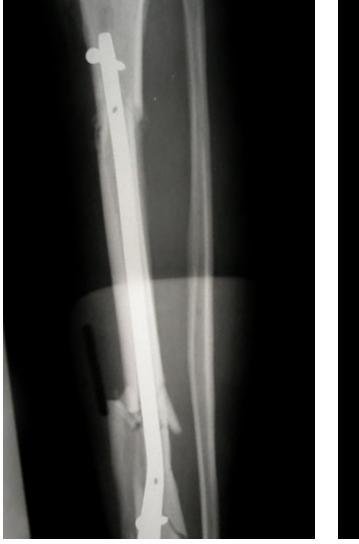
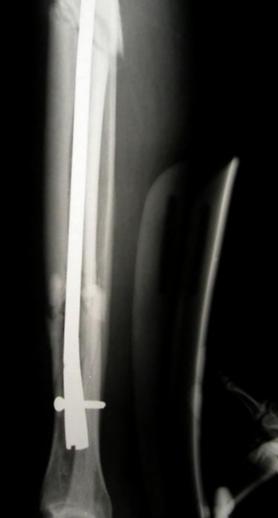
Figure 3. Postoperative AP plain film of the tibia.

Figure 4. Postoperative lateral plain film of the tibia.

The entry point for an intramedullary nail was made through the proximal portion of the medial malleolus. The canal was then reamed to 10 mm, and an  $8 \times 27$ cm Richards Delta tibial nail (Smith and Nephew, Inc., Memphis Tenessee) was placed in a retrograde fashion. The fracture displaced as the nail was placed but could again be reduced with the nail in position. This nail was locked with 1 screw both proximally and distally, and this construct was observed to be stable under fluoroscopy. The pressure sore was then treated with local wound care (Figures 3 and 4).

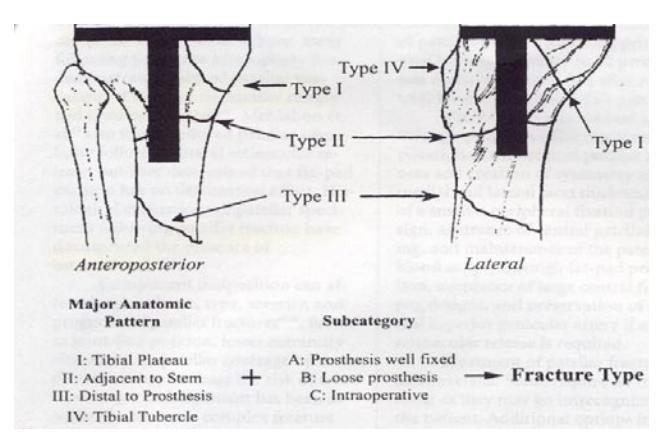
Figure 7. Mayo classification of periprosthetic tibial fractures Reprinted from Orthopedic Clinics of North America, vol. 30, Stuart MJ et al, Total Knee Arthroplasty: periprosthetic tibial fractures, p 280, Copyright 1999, with permission from Elsevier.

Periprosthetic tibial fractures can be classified based first on their anatomical location and then by their prosthetic fixation status<sup>12,14</sup> (Figure 7). Type I fractures involve the tibial plateau and the tibial component interface. Type II fractures lie adjacent to the tibial stem. Type III fractures occur distal to the stem. Type IV fractures are of the tibial tubercle. Further classification is based on the involved component stability as being A, stable prosthesis; B, loose prosthesis; or C, intraoperative fractures. Fractures that cause instability of the components (category B) are best treated with revision surgery involving longer-stem components and fixation of any associated fragments. Fractures that leave the prosthesis stable (category A) are treated with standard techniques of fracture management.

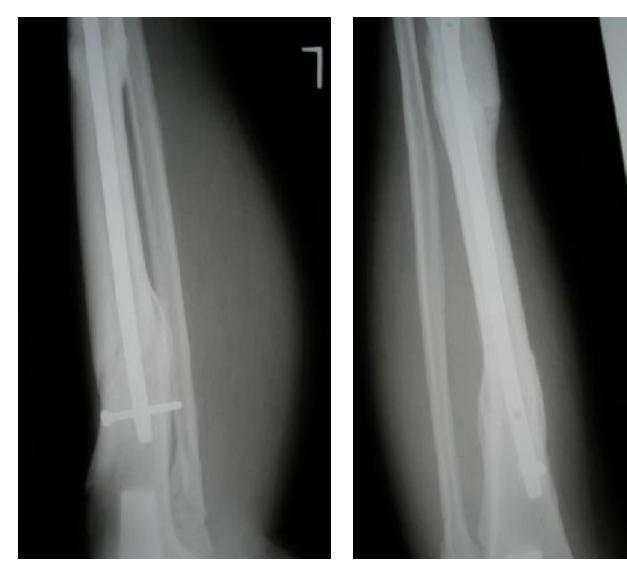
Figure 5. Anteroposterior plain film of the tibia at 2 years after surgery.

Figure 6. Lateral plain film of the tibia at 2 years after suraerv.

At 3 months, the patient was doing well and was undergoing rehabilitation. The pressure sore had healed completely, and the leg had no residual swelling. Radiographic studies revealed healing of both the tibial and acetabular fractures. The patient was recently seen 2 years out from his injury, and he continues to do well (Figures 5 and 6).
